New Accelerated Reliability Improvement Methodology with Case Studies

Hong Kong Electronics & Technologies Association 香港電子科技商會

This SME Development Fund project "To Enhance the Competitiveness of Hong Kong's Electronics Industry by Improving Product Reliability in a Short Product Development Cycle" was organized by Hong Kong Electronics & Technologies Association Limited (HKETA) with collaboration of the Hong Kong Critical Components Manufacturers Association (HKCCMA) and implemented by the Hong Kong Productivity Council (HKPC).

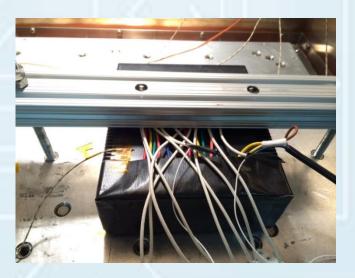
Figure 11 – Transformer of LED Light Blub

For the combined environment, the plastic case of the transformer had been removed and directly mount on the table, to prevent loosen of fixture due to the melting of the plastic case.

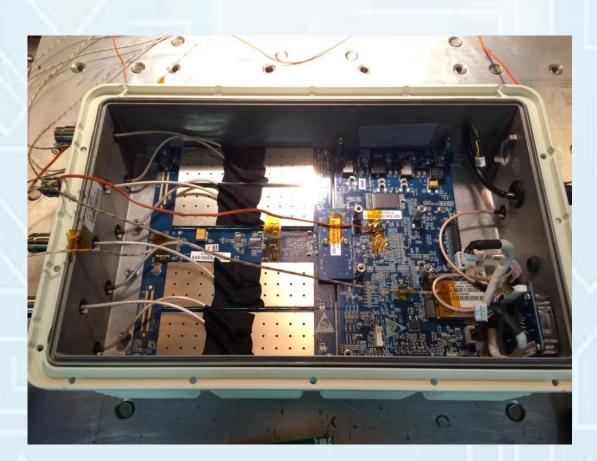
Figure 29 - Outlook of Automotive Wi-Fi Base Station

Product Category: Automotive Electronics - HALT was performed on one Wi-Fi base station which consists of multi of PCBs, e.g. surge protection board, RF board, interface board and power board. This Wi-Fi base station is designed for automotive applications.

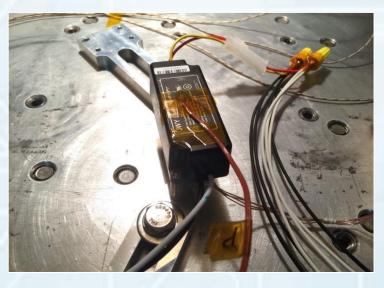
Figure 39 – Outlook of LED Driver (Overview)

Product Category: Home Appliances - HALT was performed on one LED driver of a LED light panel.

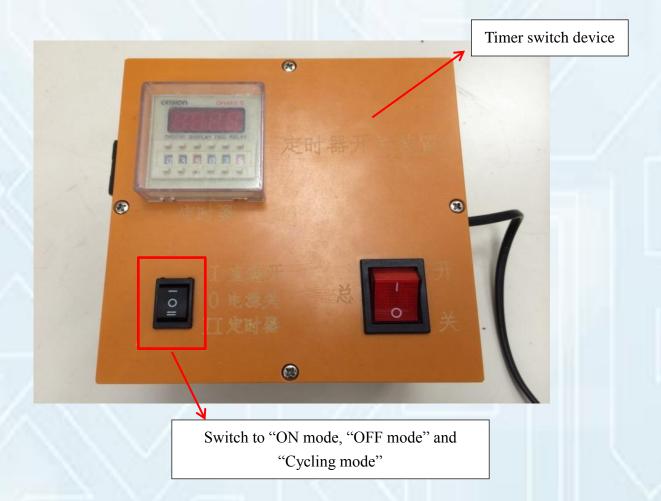
Figure 42 – Switching Test Kit Used for Function Checking

For the switching test:

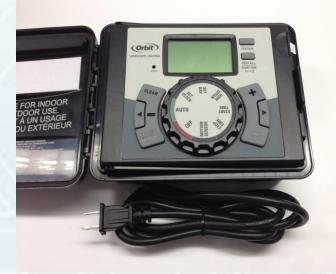
Figure 52 - Outlook of Outdoor Sprinkler Timer for Case 6

Product Category: Portable Electronics - HALT was performed on one outdoor sprinkler timer which consists of one power board, one control board and one logic board.

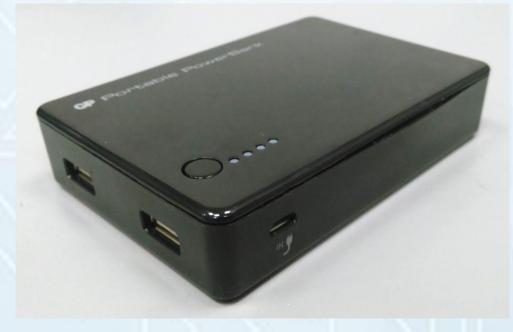
Figure 64 – Outlook of Portable Power Bank for Case 7

Product Category: Portable Electronics - HALT was performed on one control board of portable power bank.

The digital circuit board of the power bank was placed inside the HALT chamber for evaluation. It should be noted that since the battery pack may explode under high temperature and vibration, the HALT could not be applied on this item. After communicating with the participating company, it was concluded that the battery pack shall be placed outside the chamber during the evaluation process. Similar cases apply to other components with potential hazards during test. The figure below shows the connection of the Unit Under Test inside the HALT chamber.

As discussed per section 6.9.1.1, the battery pack was placed outside the chamber to prevent potential hazard of explosion due to unnecessary overstressing of product. The power board was connected with a resistive load for discharging operation. At the same time, adaptor was connected to the power pack to simulate the charging function of the Unit Under Test. The switching between charging mode and discharging mode was facilitated by a switch connected to the outside of the chamber. The current and voltage were monitored during the test process to ensure proper operation of the Unit Under Test. Figure below shows the connection setup outside the HALT chamber.

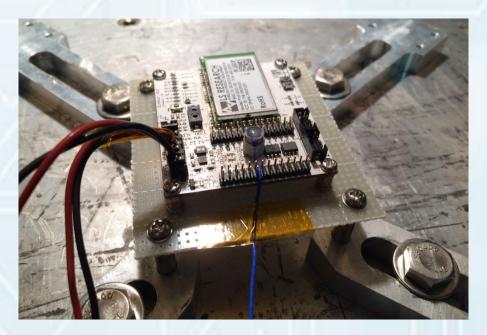
Figure 70 – Test Setup Overview for Case 8

Product Category: Others - HALT was performed on one Industrial Wireless Sensor.

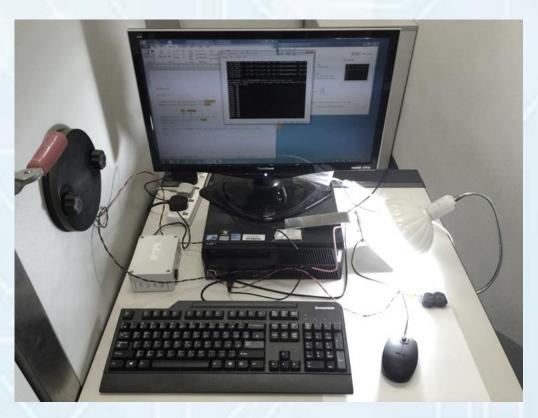
Figure 71 – Test Setup Outside HALT Chamber for Case 8

For the functional test, the industrial wireless sensor was connected to a gateway through wireless communication and a computer with testing programme is using for checking the communication among the industrial wireless sensor and the gateway.

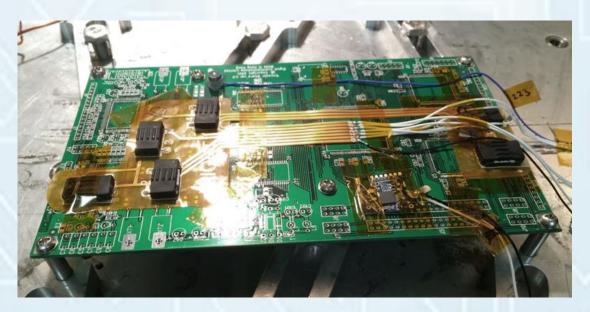
Figure 76 – Test Setup for Case 9

Product Category: Health Care Electronics - HALT was performed on one flexible printed circuit board which contains six pressure sensors and one Data Acquisition PCB board (DAQ board) of the smart pressure measuring shoe pad.

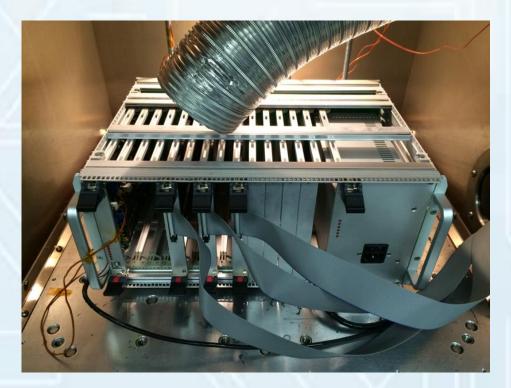
Figure 81 – Test Setup for Case 10

Product Category: Portable Electronics - HALT was performed on one portable in-circuit tester, which consisted of a PCB module (one main control board and three application boards) and a power supply module.

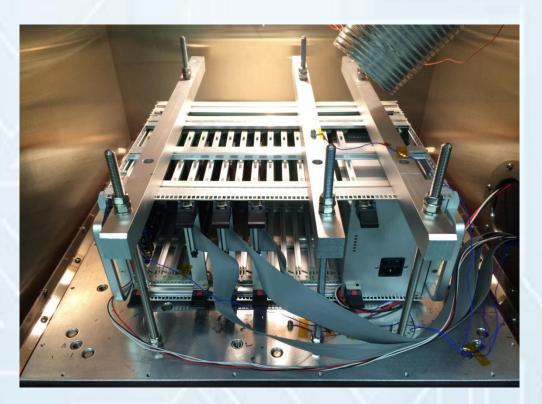
Figure 82 – Test Fixture Prepared by Participating Company for Case 10

The Portable In Circuit Tester was in a size that was not easy to be mounted on the test platform inside the HALT chamber. For this case, the Participating Company had to specially design a test fixture which could mount the Unit Under Test to the test platform. Figure 82 shows how the test fixture worked as a part of the test setup.

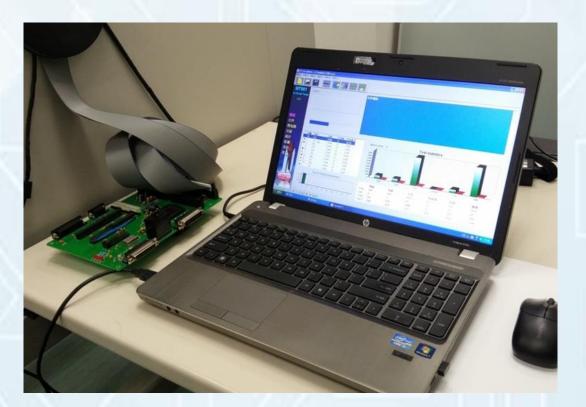
Figure 83 – Function Checking Setup for Case 10

The portable in-circuit tester was connected to a demo board by flexible cables and a computer with testing programme by USB cable.

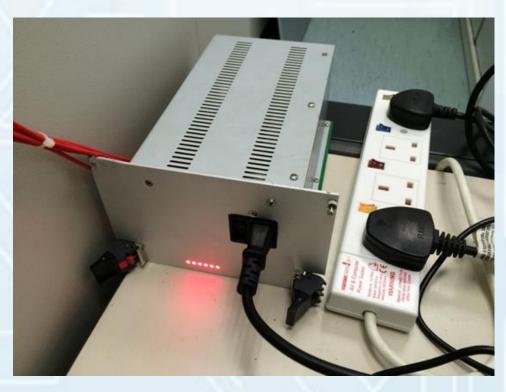
Figure 86 – Power Supply Module Being Taken Out From the Chamber as a Second Reliability Trial for Case 10

Compare to the initial HALT test, the power supply module was extracted from the test and located outside the chamber for this improvement test, since it was acceptable by the participating company that the function of the power supply should be count outside the reliability consideration. The failure mode of the power supply was agreed and acknowledged by the participating company.

The test setup is updated as shown in the below figures.

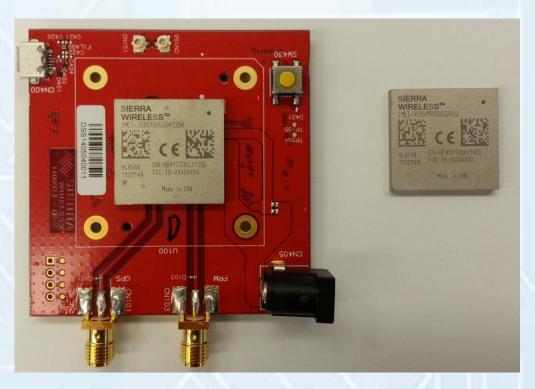
Figure 87 – Outlook of Wireless Embedded Module for Case 11

Product Category: Others - HALT was performed on 3 wireless embedded modules in each part of test.

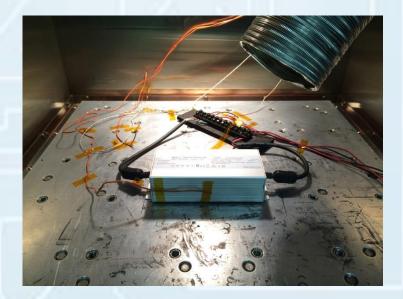
Figure 93 – LED Driver Inside HALT Chamber for Case 12

A 240V AC voltage was applied to the LED driver, and five pieces of 6 inch LED light source were connected to the LED driver as loading. The LED light loadings were placed outside the chamber during test.

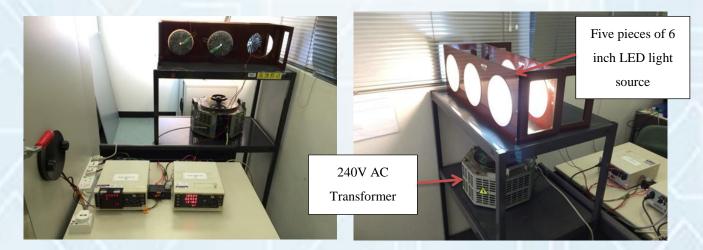
Two digital power meters were connected to the LED driver, and the input voltage, input current, power factor, output voltage, output current and output power were measured for the functional test.

Figure 94 – Upper: Functional Checking (Power Supply Monitoring) Setup for Case 12

Figure 95 – Lower: Functional Checking (LED Function) Setup for Case 12
