RaSpect

Predictive AI for the safety of built infrastructure

Win-Win Partnership: Elevating Building Inspection

The Problem with Manual Inspection & RaSpect AI Inspection Solution

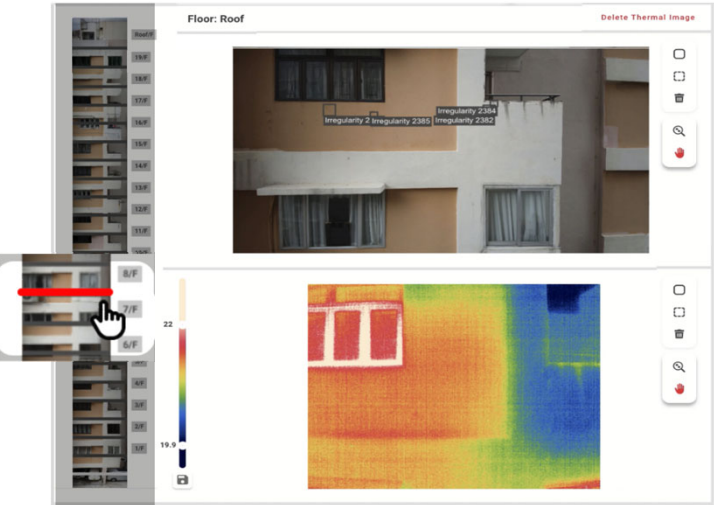
▲ Lower Floor

**Data Upload &
AI Data Localization**

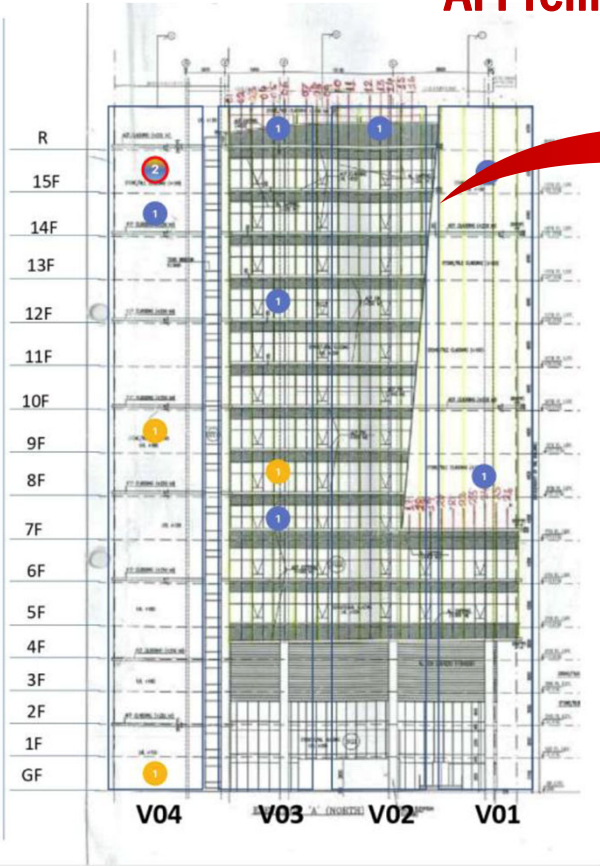
▲ Auto-suggested Defect Tagging

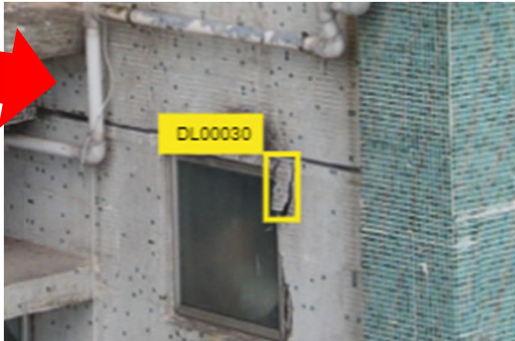
▲ AI Defect Analysis

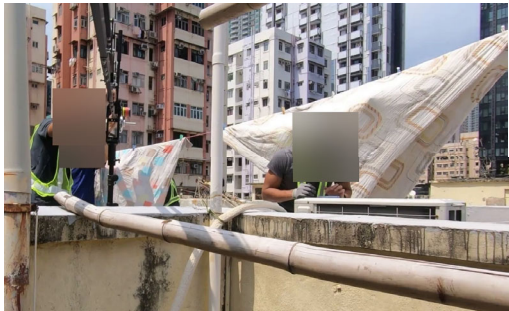
▲ Automatic Privacy Filter

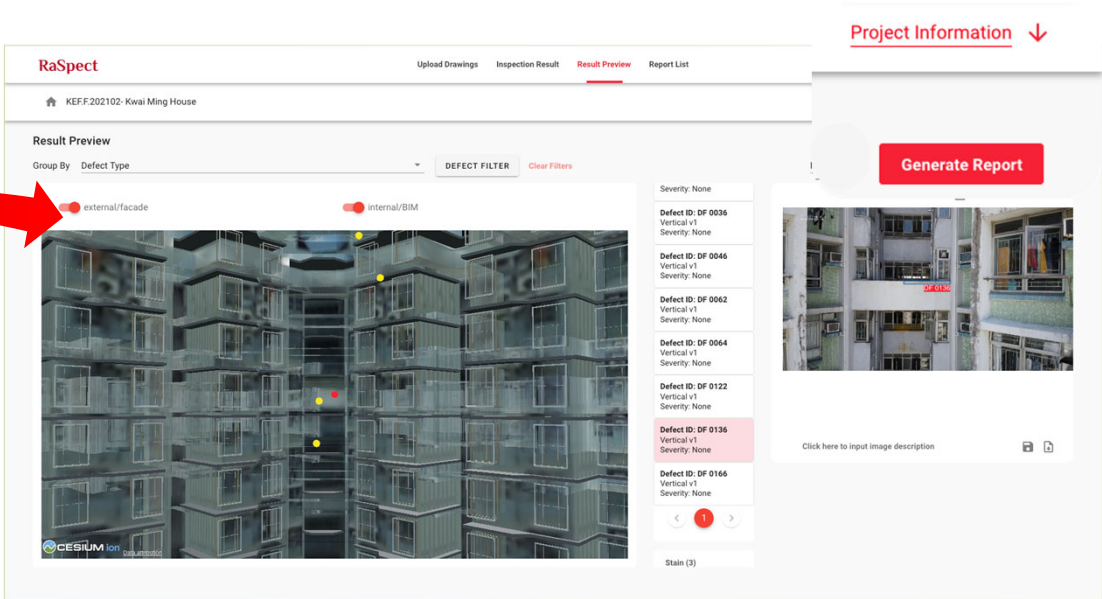
▲ Result Preview (3D/2D)

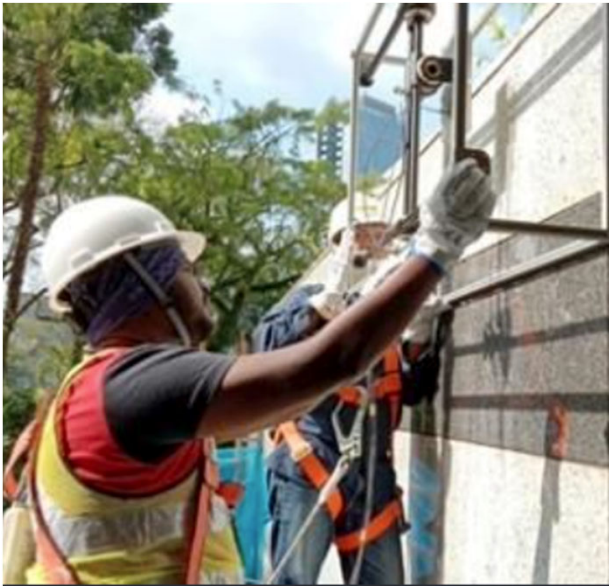
▲ Data Collection for selected areas that require detailed inspection

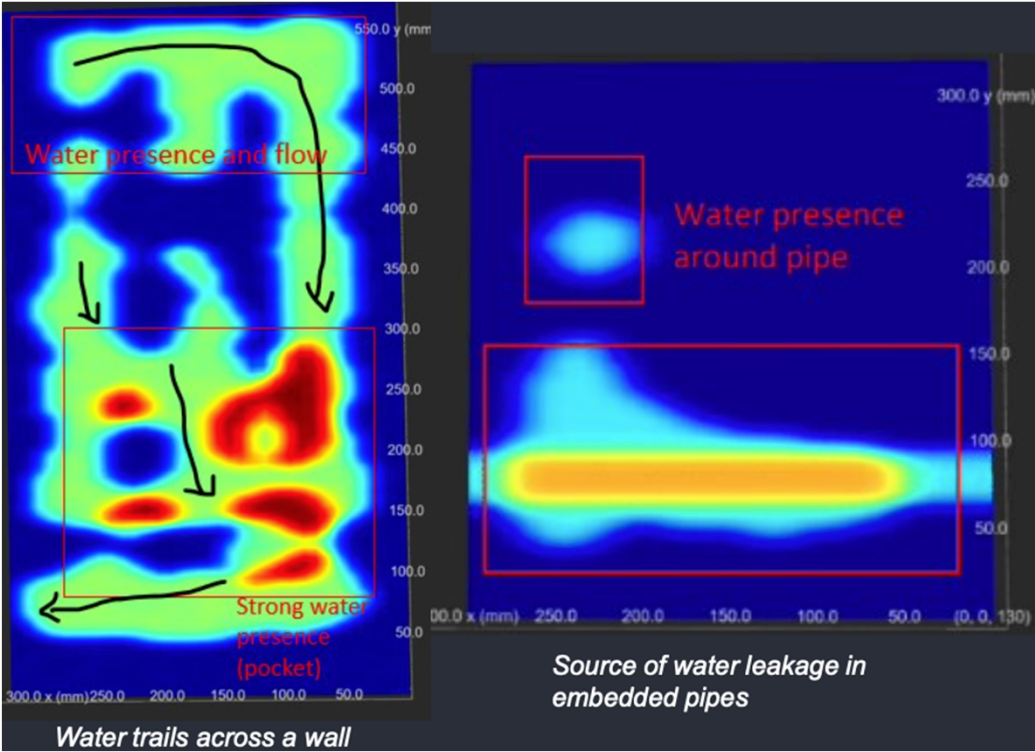
▲ Use Case: Detection of Water Seepage in Concrete

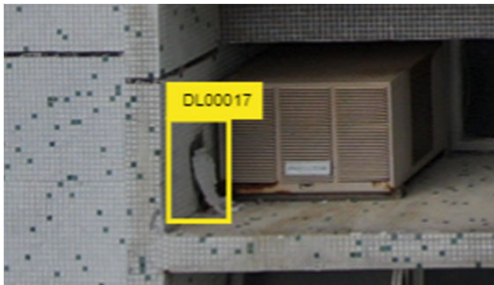
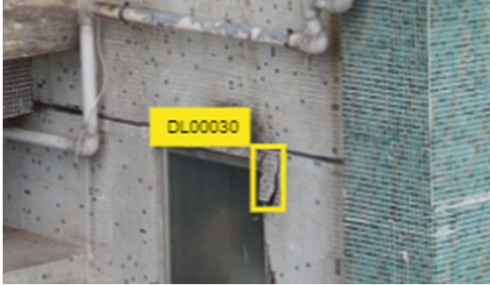
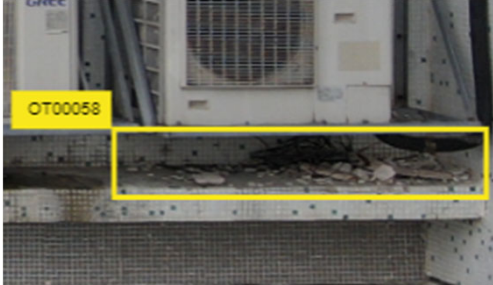
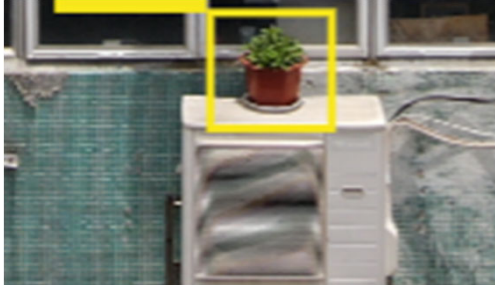
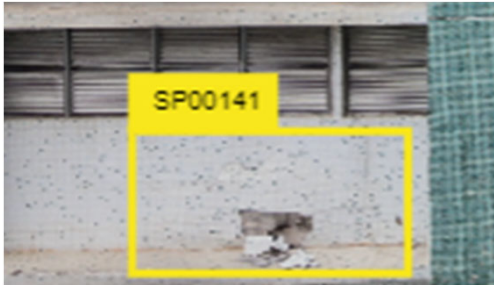
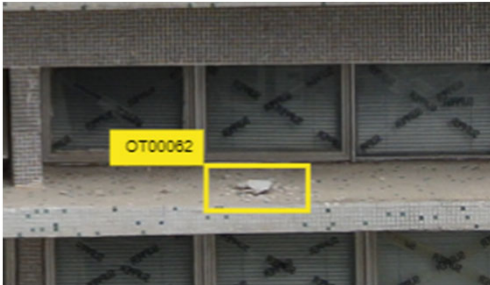
Severity - Critical Defects

Spalling, Delamination, Loose objects, Falling object Risk

Cause	Description	Consequence/Impact
The critical defects on building façade occur due to long neglected repair and maintenance that leads to objects such as spalled concrete, broken tiles, delaminated claddings or corroded metal components etc. becoming loose presenting an imminent danger of falling objects.	The critical defects are the ones that are caused by any object such as a loose piece of concrete, broken piece of tile or any components attached to the building façade which may be in imminent danger of falling off causing risk of injury to occupants or members of public.	<ul style="list-style-type: none">• Can cause severe injury or even death to persons by falling objects from building façade.• Represents a building in poor condition or disrepair• Should be attended to immediately

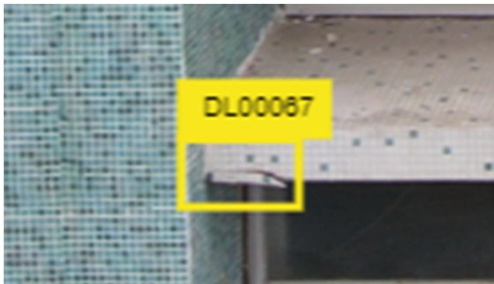
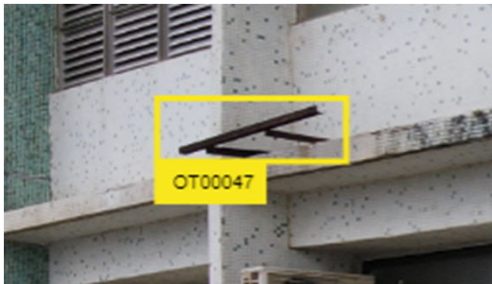
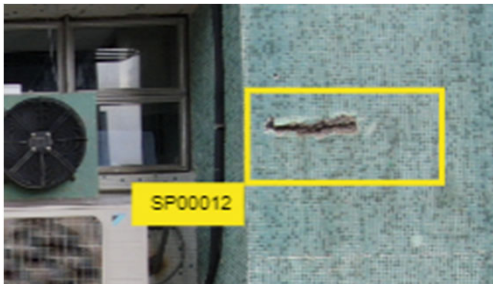
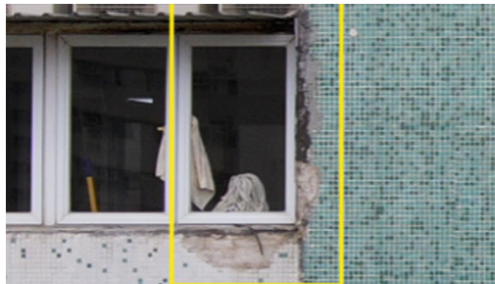
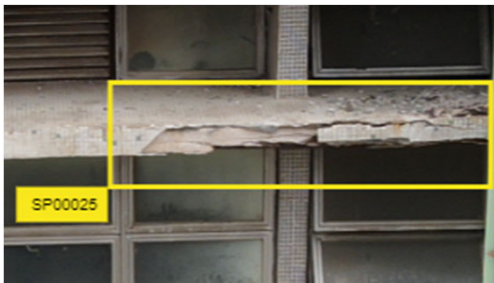
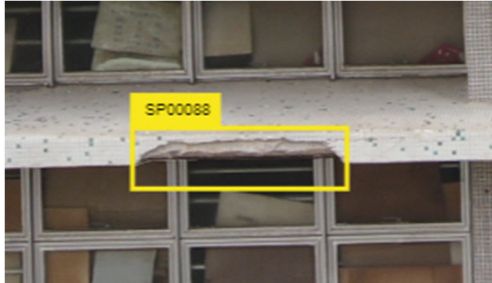
Severity - Major Defects

Cracks, Spalling, Delamination, Corrosion, Falling object Risk

Cause	Description	Consequence/Impact
The major defects on building façade occur due to long neglected repair and maintenance that leads defects such as cracks, spalling, delamination of large size representing danger to the safety of the building and sometime falling object risks. These defects may also develop due to overloading, ad hoc alterations, UBW, foundation movement etc.	The major defects are the ones represent safety risk to the building and in some cases falling object risk although not immediately. Large cracks, spalling, delamination, corrosion of steel, missing tiles, cracked glass or claddings would fall in this category. Typical dimension would be 0.1 sq m area affected per defect or crack width of 1 mm or above.	<ul style="list-style-type: none">• Can result in collapse of part or all of the building.• Could lead to falling object incidents if unchecked.• Can be expensive to repair

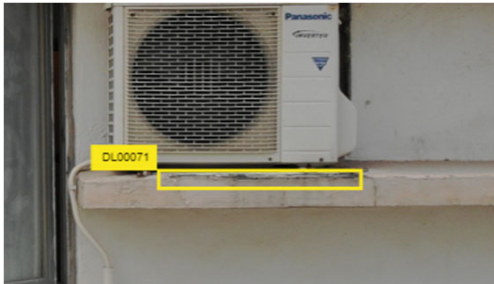
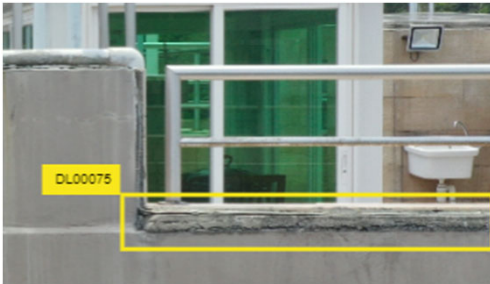
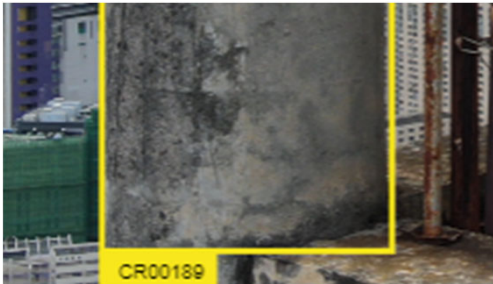
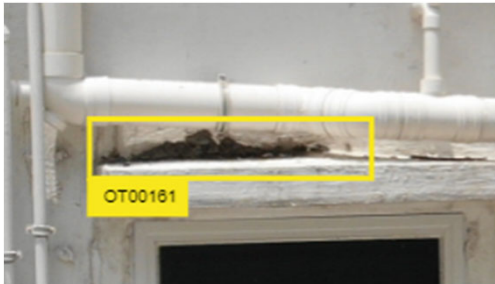
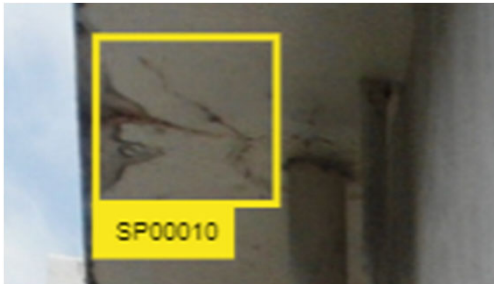
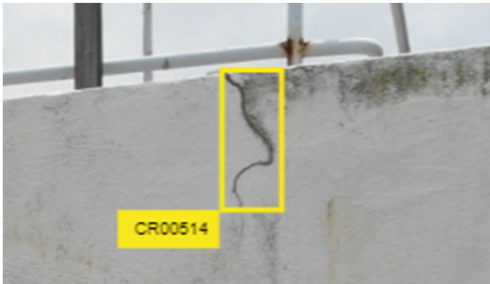
Severity - Moderate Defects

Cracks, Spalling, Damp, Missing Tiles, Chipped Tiles, Rust

Cause	Description	Consequence/Impact
The moderate defects on building façade occur due to neglected repair and maintenance that leads defects such as cracks, spalling, delamination, dampness of large that may affect the functionality of the building. These defects may also develop due to overloading, ad hoc addition and alterations (A&A), UBW, foundation movement etc.	These defects affect usage of the asset and may pose a medium risk to the members of the public. Regular monitoring is recommended. Perform repair whenever possible. Remedial measures are recommended in individual defect section.	<ul style="list-style-type: none">• Can affect functionality and durability of the building.• Could lead to higher category of severity if unrepaired.• Can be difficult to repair – especially moisture issues

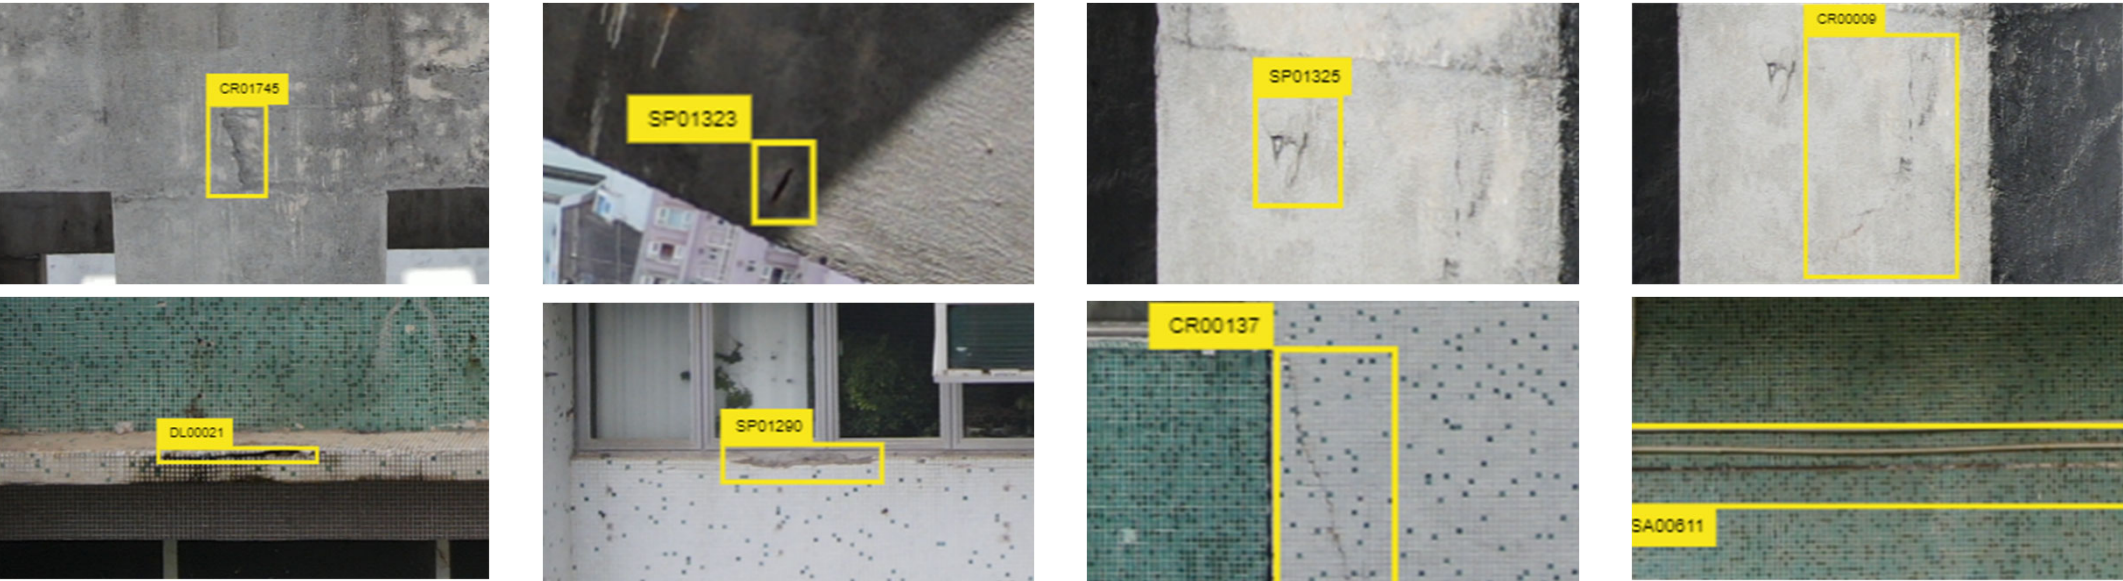
Severity - Minor Defects

Cracks, Spalling, Damp, Missing Tiles, Chipped Tiles, Rust

Cause	Description	Consequence/Impact
The minor defects on building façade occur due to neglected repair and maintenance or defective workmanship that leads defects such as cracks, spalling, delamination, dampness of relatively small size that may affect the safety and functionality of the building in future left neglected.	Defects that may affect safety and/or functionality in the future. Periodic monitoring is recommended since the defect may develop into a more severe class.	<ul style="list-style-type: none">• Unpleasant look for the building.• Can affect functionality and durability of the building in future.• Could lead to higher category of severity if unrepaired.• Should be monitored

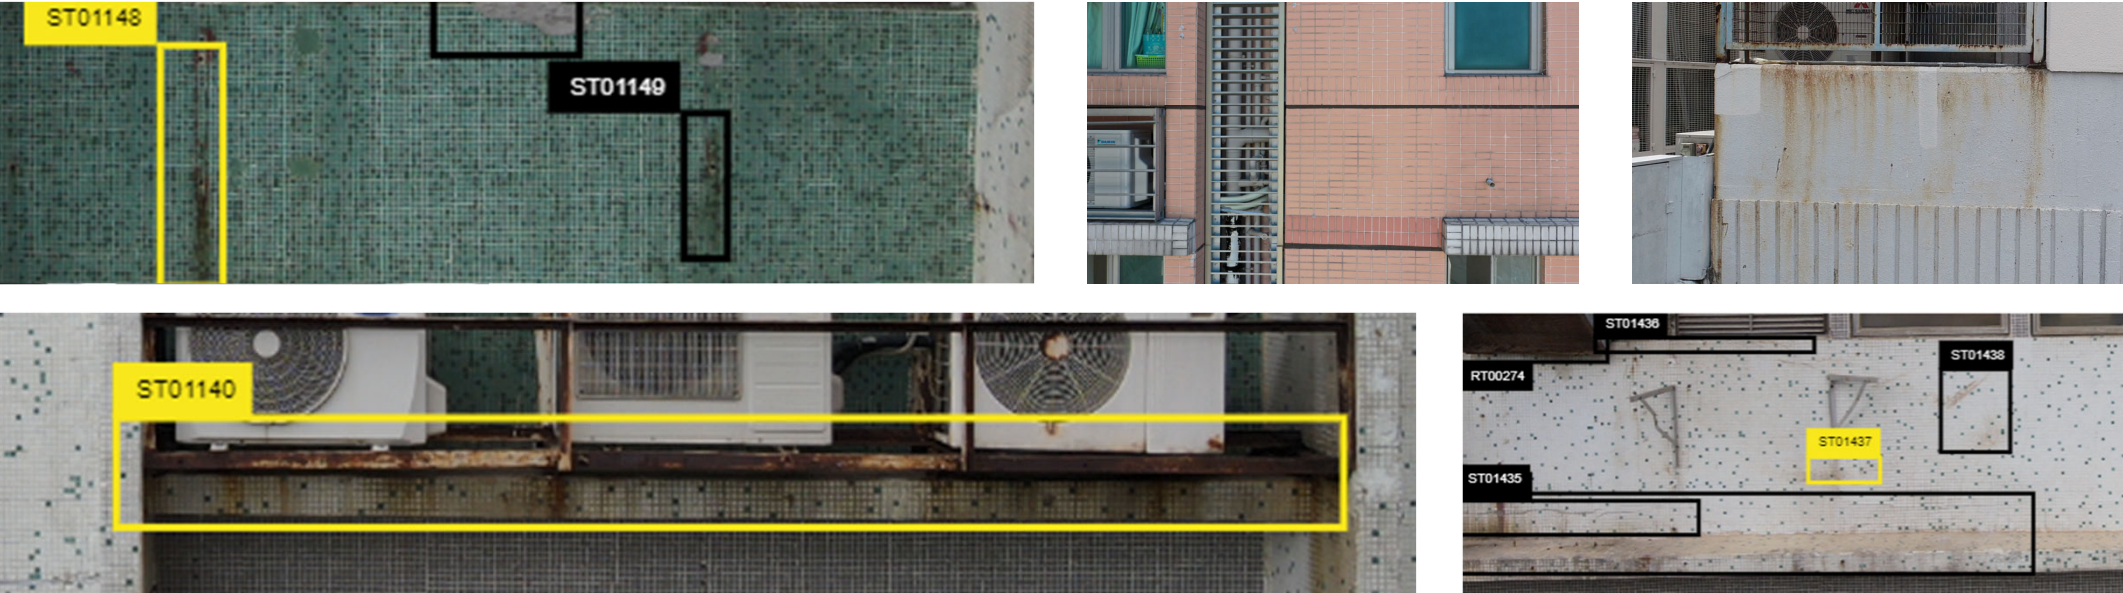
Severity - Cosmetic Defects

Stains, Rust, Efflorescence, Discolouration, Fading, Mismatched

Cause	Description	Consequence/Impact
The cosmetic issues on building façade occur due to maintenance and natural wear and tear due to the exposure to the weathering elements. It leads to stains, discoloration, fading etc. of the building façade.	Issue that affects only appearance or aesthetics without posing any safety or functionality risks. Corrective action is discretionary.	<ul style="list-style-type: none">• Affect look of the building• Can decrease market value

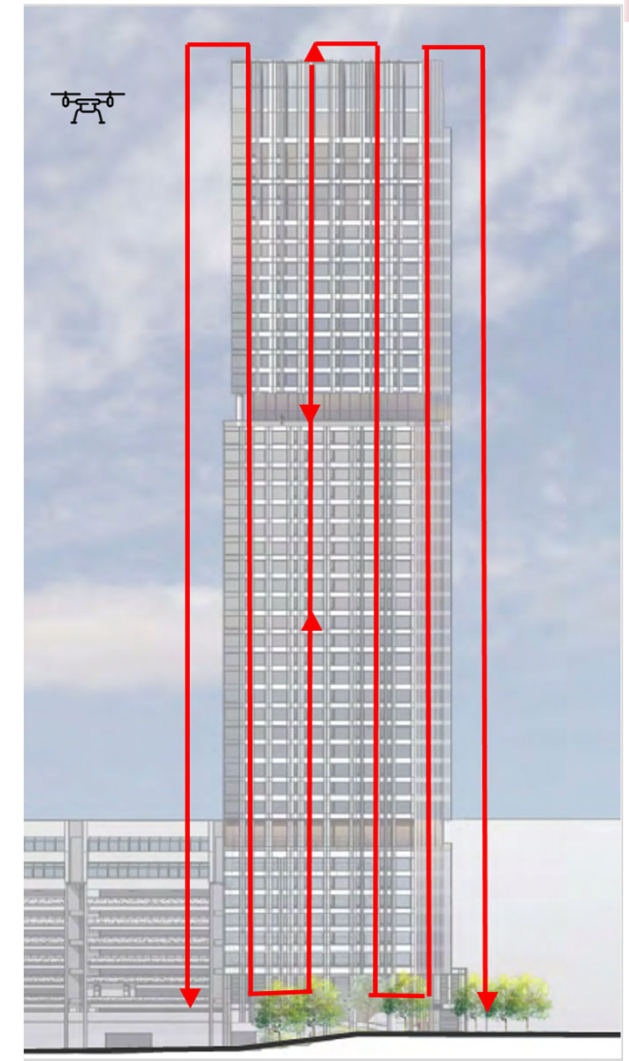
- Pre-set the flight path in a grid pattern for autonomous Unmanned Aerial Vehicle inspection
- Unmanned Aerial Vehicle shall photograph by scanning vertically and/or horizontally for optimal coverage
- Unmanned Aerial Vehicle captures images via 4 different directions (E>S>W>N)
- All images would be geo-tagged with GPS information.
- Co-Pilot records the operation details in a time-log for reference check, to reassure the location of the captured data.
- Unmanned Aerial Vehicle will fly closer to building for defects closeup.

▲ (Ref. Case) Sample illustration of drone flight path

Limitation: Constrained facade regions, like light well and inner corners of the buildings, may not be favorable for aerial data capturing. The operation team will try to capture data at an angle to compensate as much as possible.

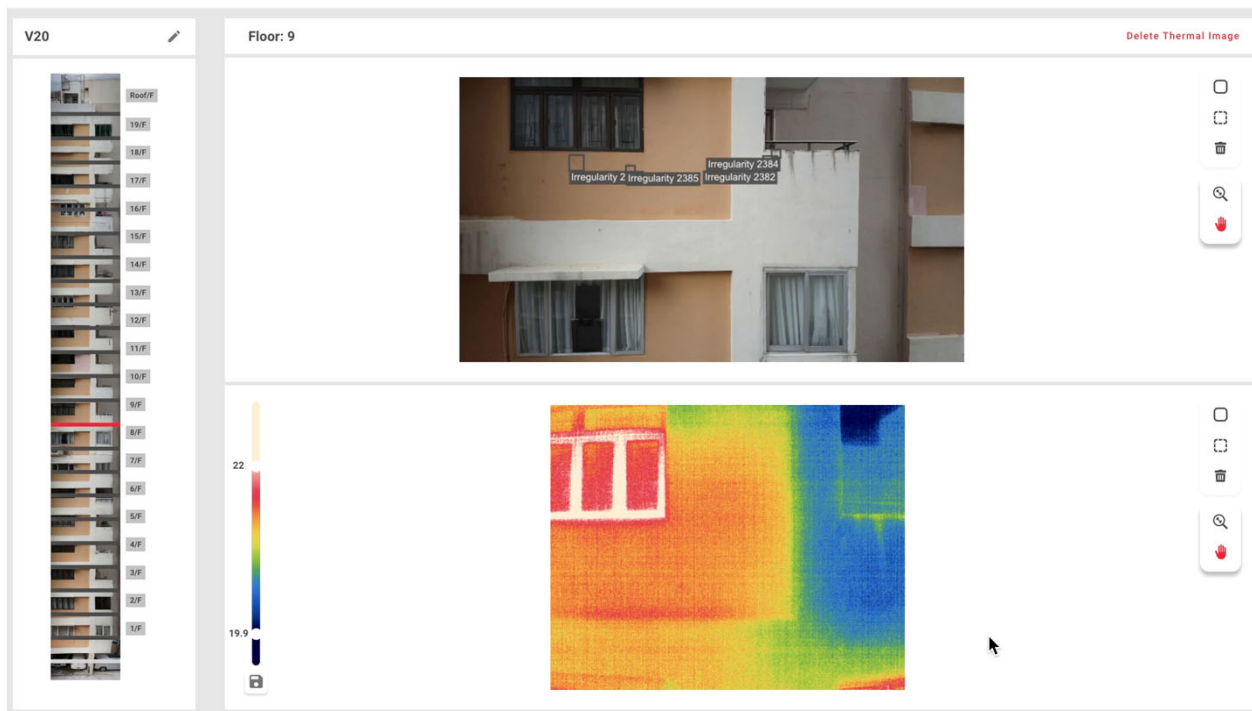
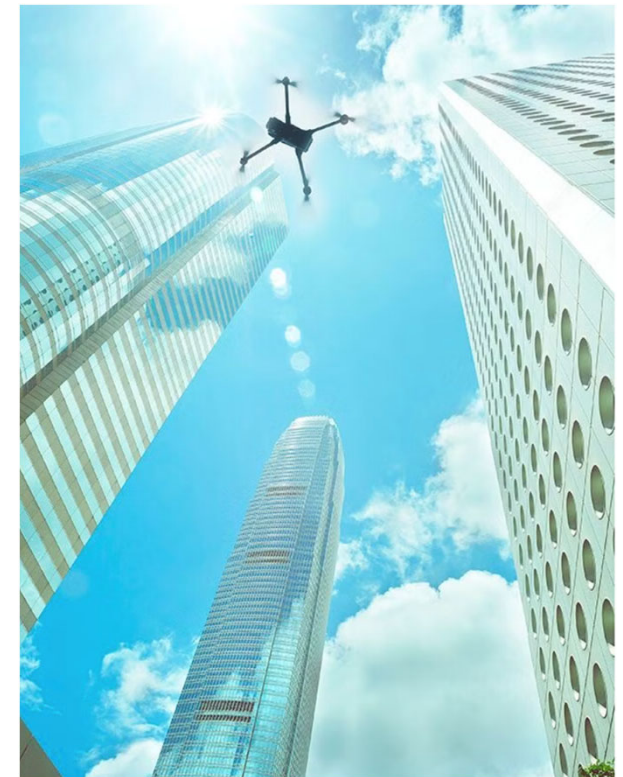
1A. Drone based – Aerial Data Collection (Visual & Thermal)

Systematic high definition visual and thermal survey of designated roof, cladding, curtain wall and high ceiling area supplemented with high resolution still photos for identified problem areas. Includes careful flight path documentation of all areas scanned for clear identification when post processing.

▲ (Ref. Case) Data collection, localisation and defects finding by using AI-Powered Analysis Algorithm

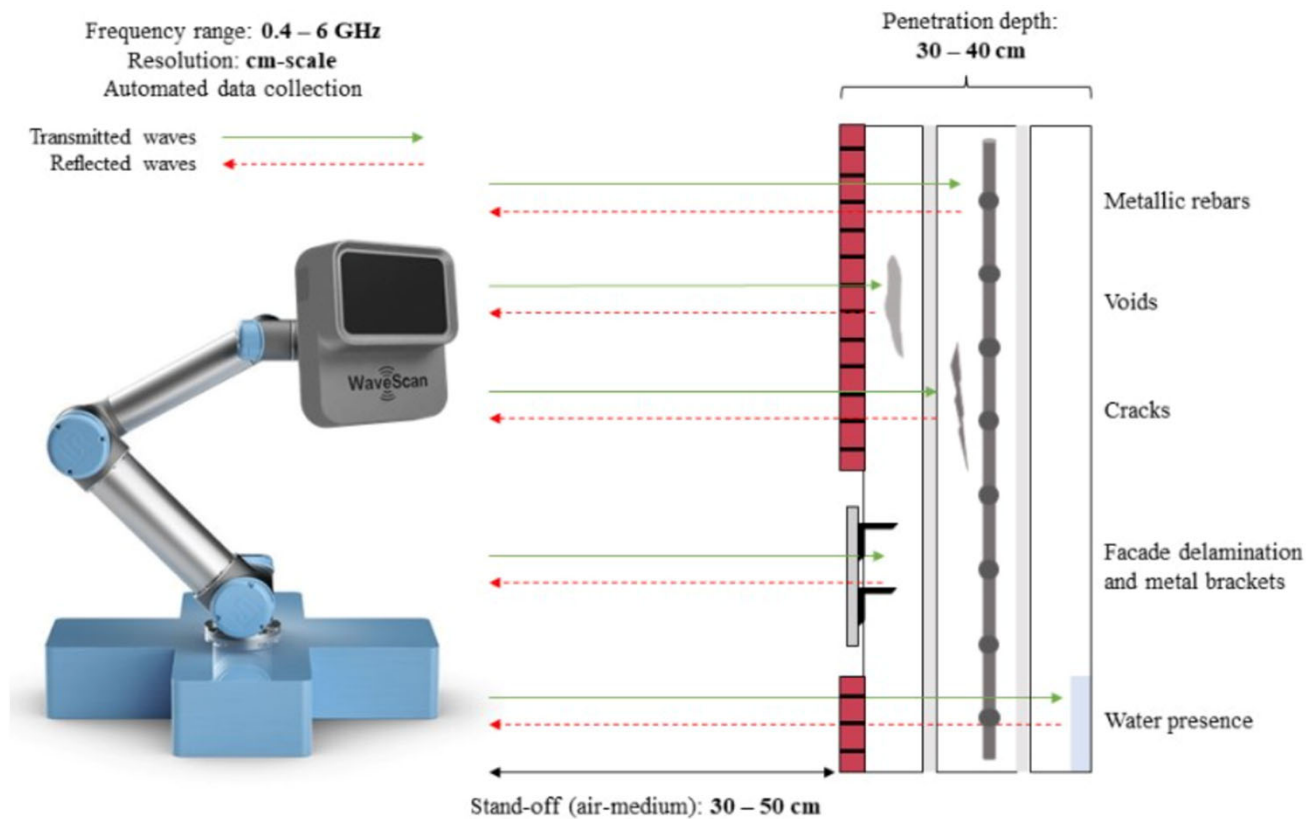
1C. Microwave based – Holographic Imaging Data Collection

A first of its kind non-contact see-through imaging technology that compliments visual inspections for identifying embedded defects or hidden source of water seepage inside cladding.

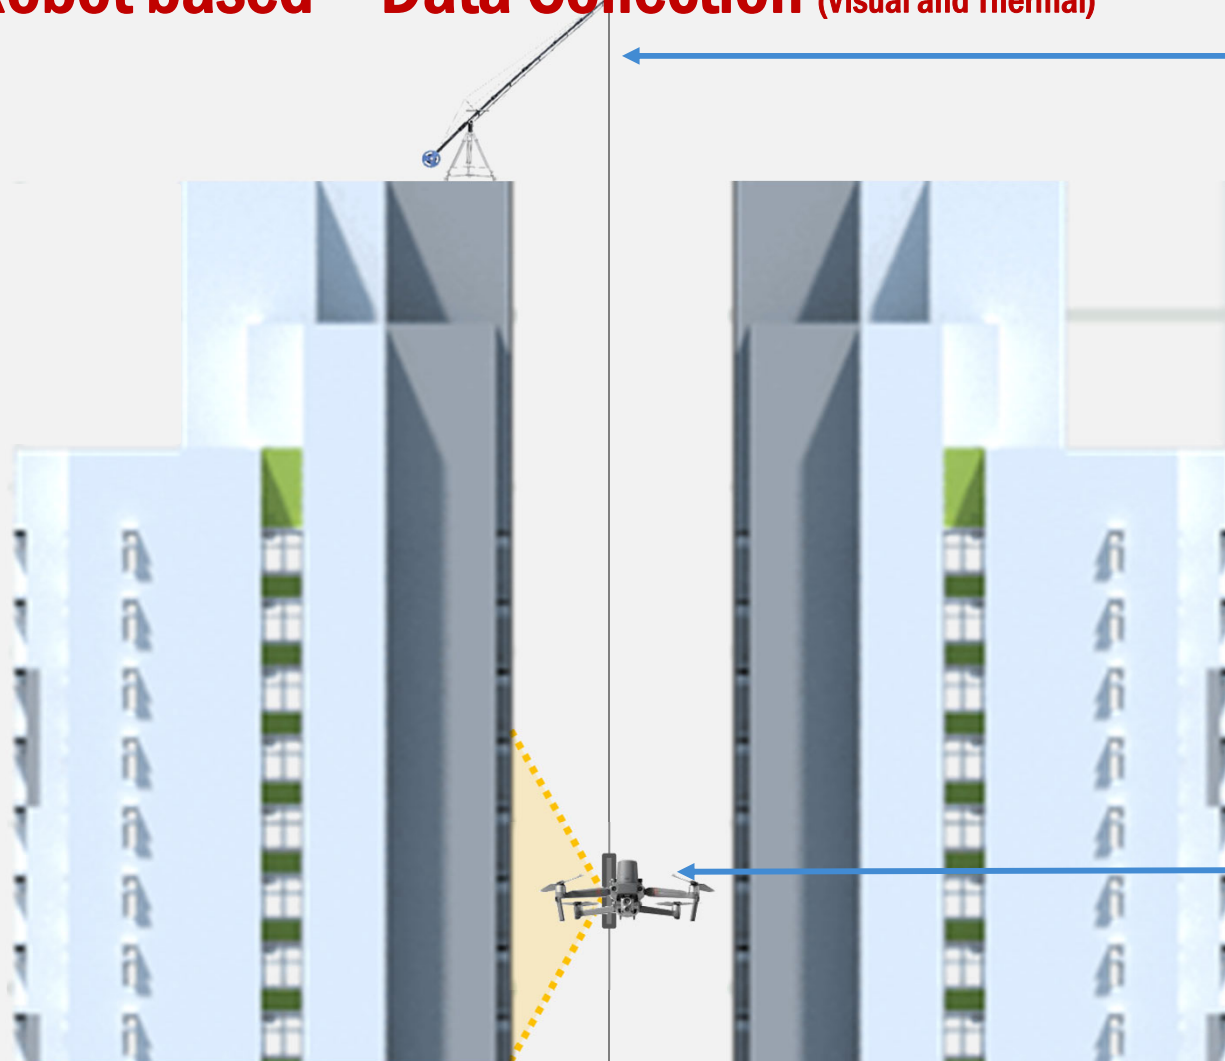
1D. Robot based – Data Collection (Visual and Thermal)

Guiding System

- Cable jib system
- Suspend wire-ropes towards the ground
- Secured on the roof for additional safety

UAS (Drone)

- Equipped with infrared and visual camera
- Protected by propeller guard
- Can equip lighting for illumination

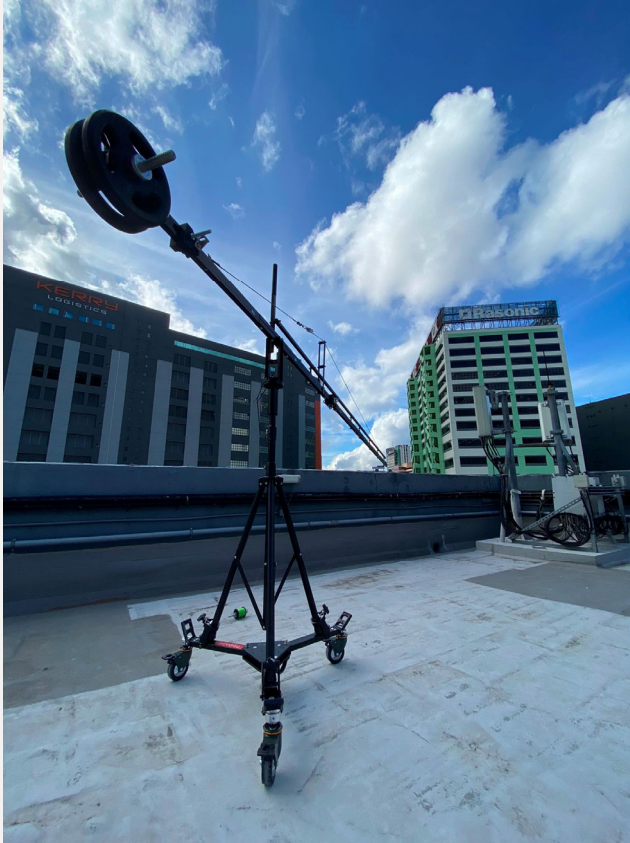
Generation 1

1D. Robot based – Camera Jib System

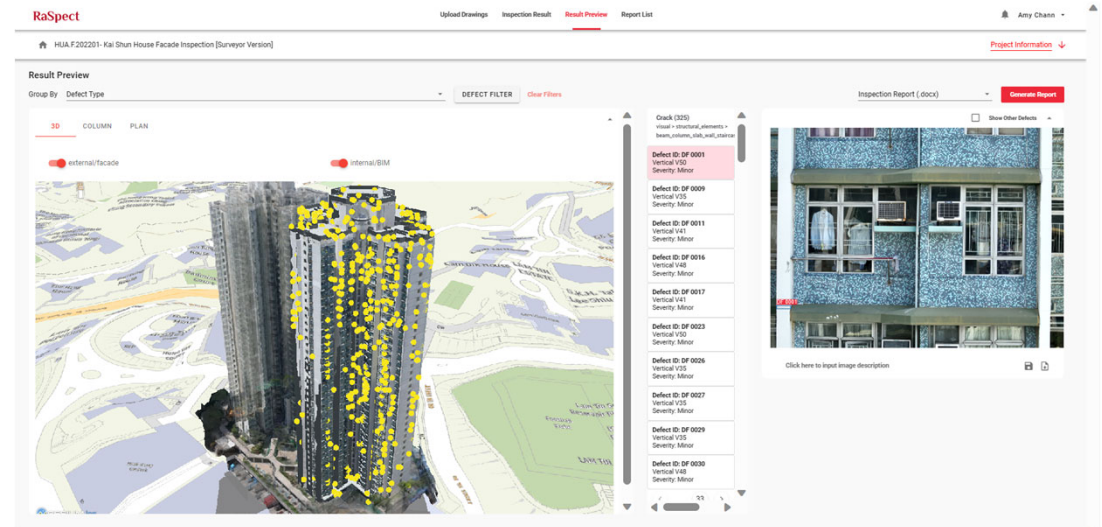
Inspectica™ as a platform for client to review all project details, including assorted raw data, comment from surveyor/engineer partner:

- I. Image record of the data captured area
- II. Identify and localize the irregularities to corresponding area on the elevation

▲ (Ref. Case) Sample dashboard of Inspectica™ platform
